# Post-strengthening of reinforced concrete beams with prestressed CFRP strips Part 2: Analysis under cyclic loading

This paper shows the results of an experimental program developed at LEME-UFRGS, in Brazil, and at EMPA, in Switzerland, regarding the application of CFRP post-strengthening on concrete structures. Continuing the results of the first part of this paper, this second part analyses the behavior of concrete beams post-strengthened with prestressed CFRP under cyclic loading.

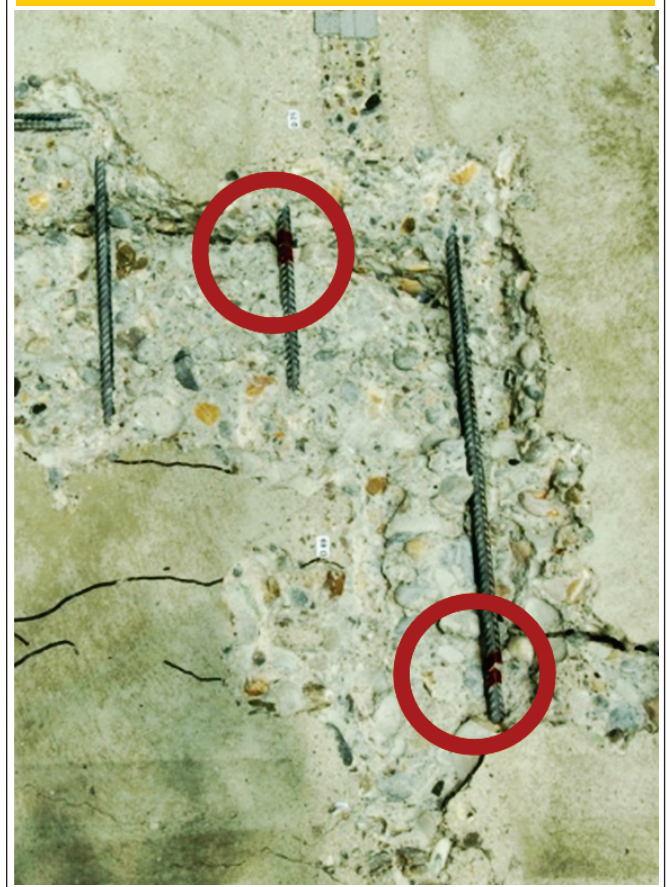
Meier U. [2] highlights that the steel rebars fail before the FRP post-strengthening, as can be seen in Figure [01] that shows the steel rebars of a post-strengthened concrete beam after a fatigue failure. However, cyclic loads can also damage the adhesive and affect the interface concrete-adhesive and adhesive-FRP, leading to premature failures.

Figure 1 - Failure of concrete beam after fatigue loading test

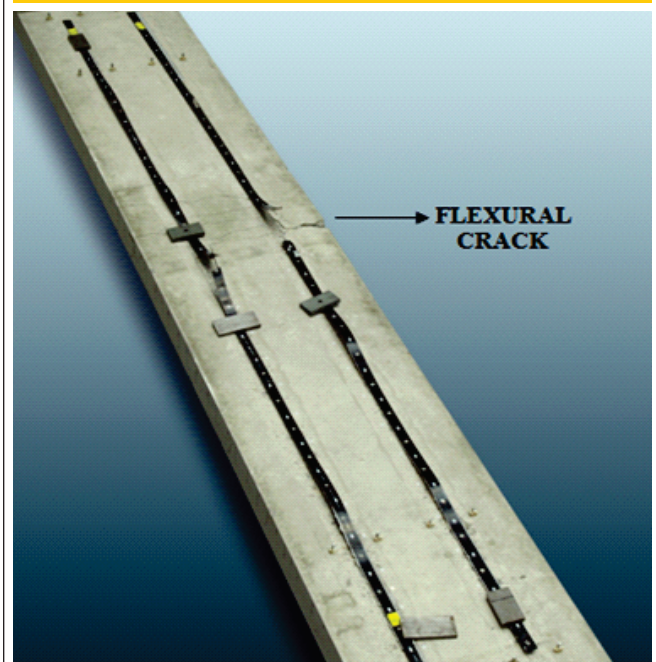
Figure 3 – Beam VFC\_PC\_01 after failure

reached. When the first strip debonded, the sudden release of the pre-tensioning force caused a compressive failure at the CFRP, as a secondary failure (Figure [03]).

The secondary failure occurred in a region that was damaged due to the presence of the flexural crack showed in Figure [03], which reached about 90% of the cross-section. Figure [04 (b)] shows one of the CFRP strips after the failure of the post-strengthened beam.

Flexural crack showed in Figure [03] induced the identification of a steel rebar broken due to fatigue. After the test, the concrete was removed from the bottom of the beam and all steel rebars were inspected. Figure [05] confirms the existence of more steel rebars broken also due to fatigue.

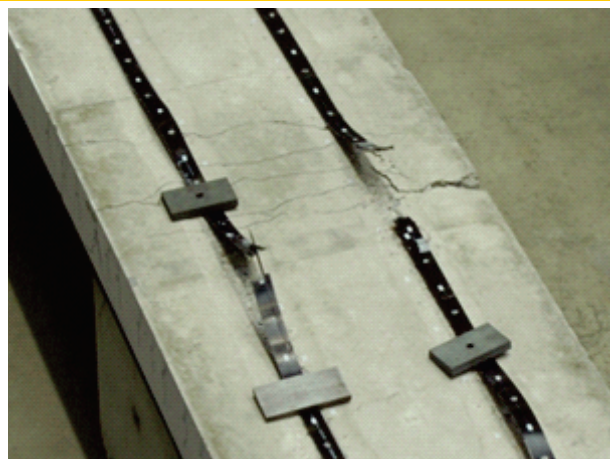
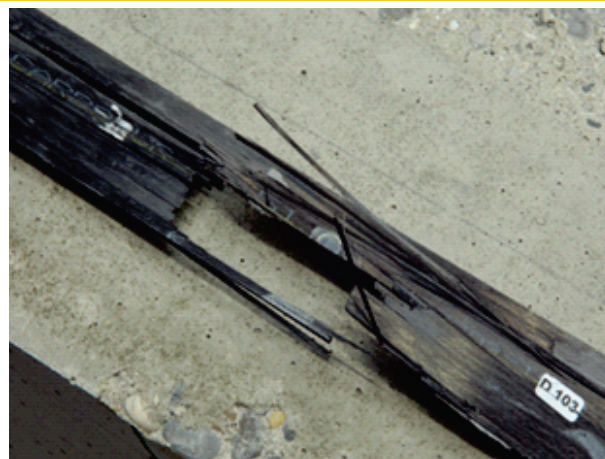
Figure 4 – Failure of post-strengthening strips: (a) Next to a flexural crack; (b) Distant from flexural cracks

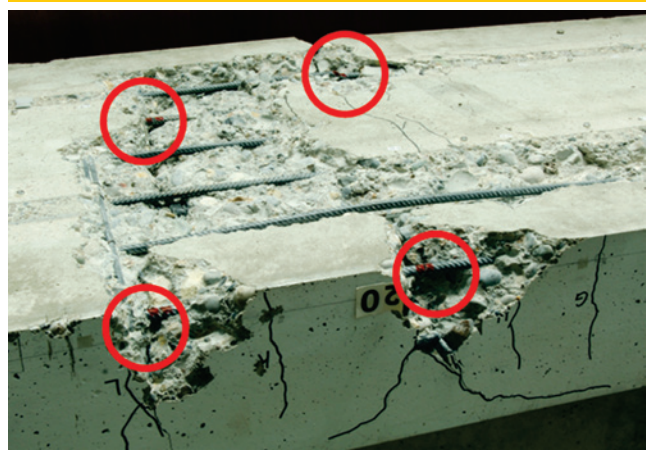
Figure 5 – Fatigue failure of steel rebars

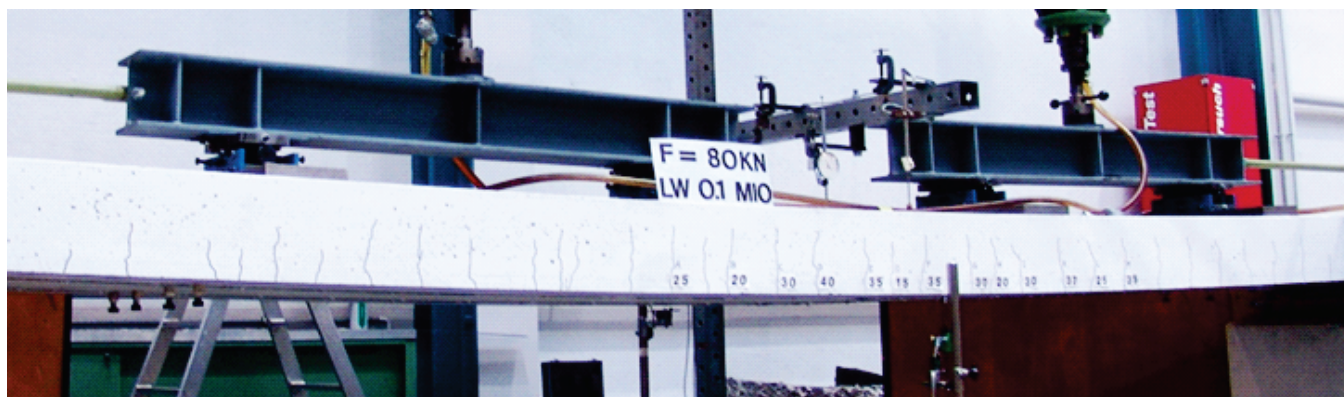
Figure 9 - Cracks at mid-span of beam VFC\_PC\_01 after 100.000 cycles

The strategy adopted to monitor the crack growing at mid-span of beam VFC\_PC\_01 can be observed at Figure [09]. Results of crack openings and the respective position from the left end of the beam are shown in Figure [10].

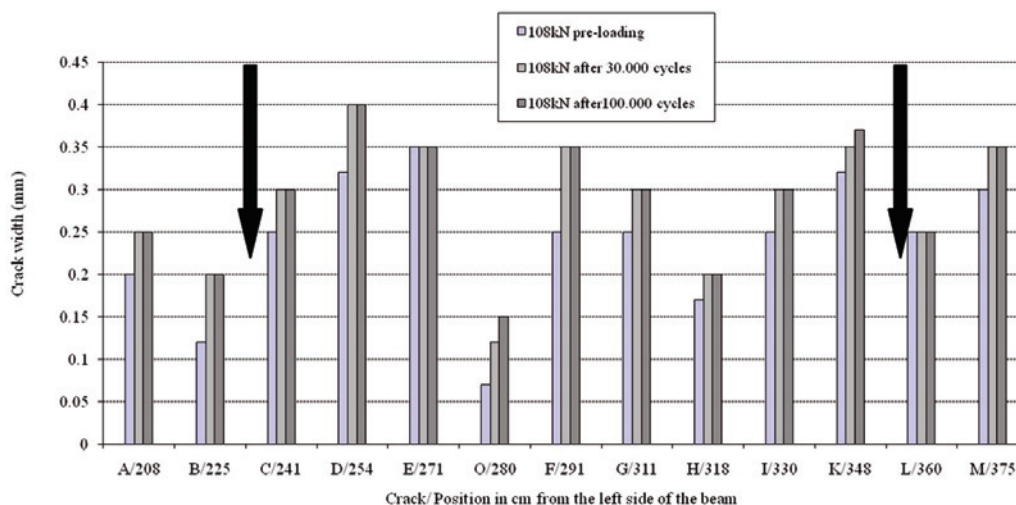
A high concentration of cracks can be observed at the mid-span of beam VFC\_PC\_01, between the four loading points. Figure [10] shows the crack openings at mid-span between the two central loading points (signaled on the figure by two vertical arrows). It is noteworthy that, before 100.000 cycles, crack openings did not reach 0,05mm.

The highest crack opening after 100.000 cycles, named D, was 0,4mm, located 254cm from the left side of the beam. However,

Figure 10 - Cracks at mid-span of beam VFC\_PC\_01 after 100.000 cycles

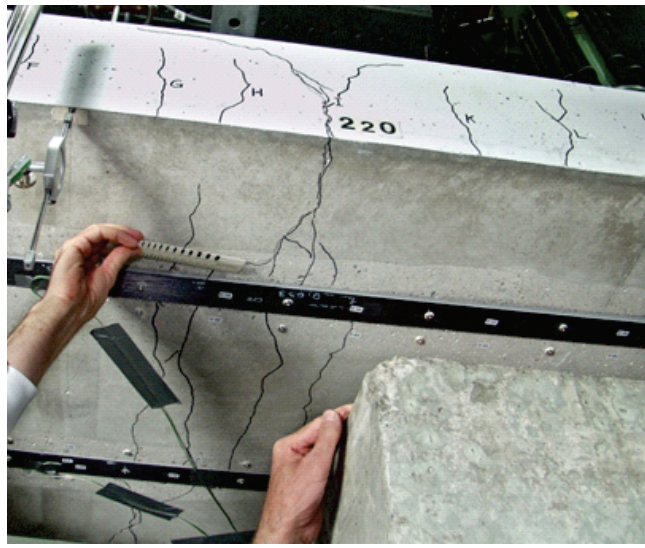
apparently the post-strengthening failed due to a 2,2mm crack opening, named I, after 331.300 cycles. It is important to notice that, after 100.000 cycles, this crack opening was about 0,3mm (Figure [11]).

Figure 11 - 2,2mm width crack at mid-span of beam VFC\_PC\_01 after post-strengthening failure

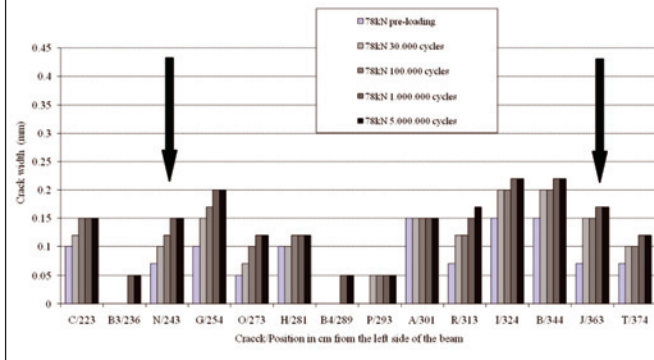
Crack growing at mid-span of beam VFC\_PC\_01 can be observed at Figure [17], which shows the results of all crack opening measurements made, from pre-loading up to 5.000.000 cycles. Figure [17] shows the results of crack openings and the respective position from the left side of the beam, at mid-span, between the two central loading points (signaled on the figure by two vertical arrows. First cracks at mid-span appeared during pre-loading, reaching less than 0,15mm. From this point up to 100.000 cycle, crack openings increased, but did not exceed 0,20mm. After 1.000.000 cycles the maximum crack opening was 0,22mm, and, after 5.000.000, this value was not exceeded.

**Figure 17 - Cracking at mid-span of beam VFC\_PC\_2 during test**
